Survey Audits and Investigations

Garth Falloon – Cadastral Survey Advisor Office of the Surveyor-General

Toitū Te Whenua LINZ Survey Audits and Investigations ICS Christchurch 2022

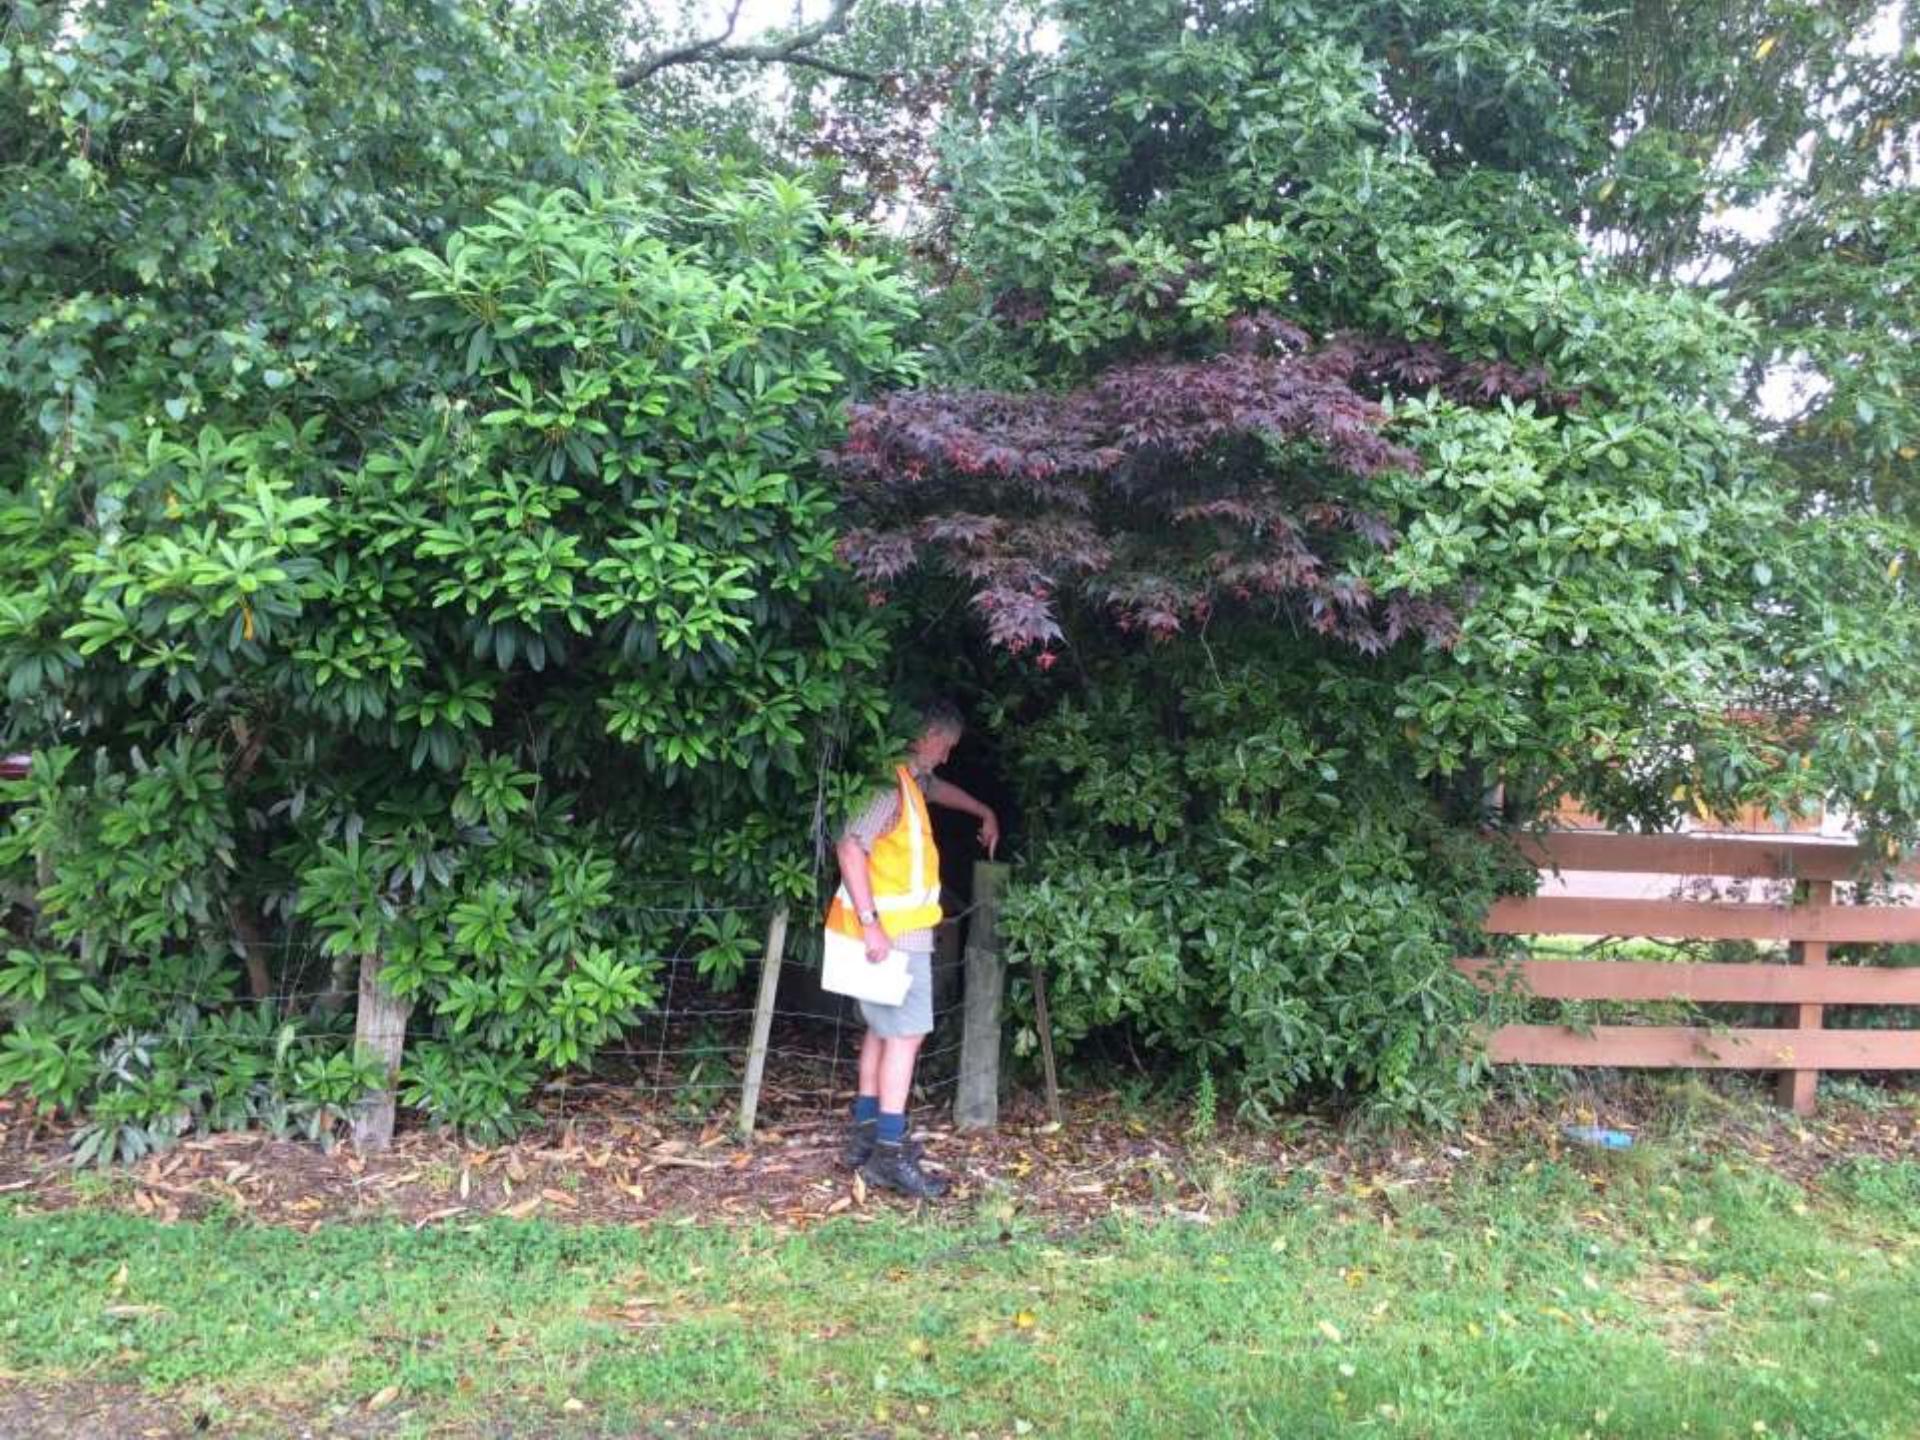
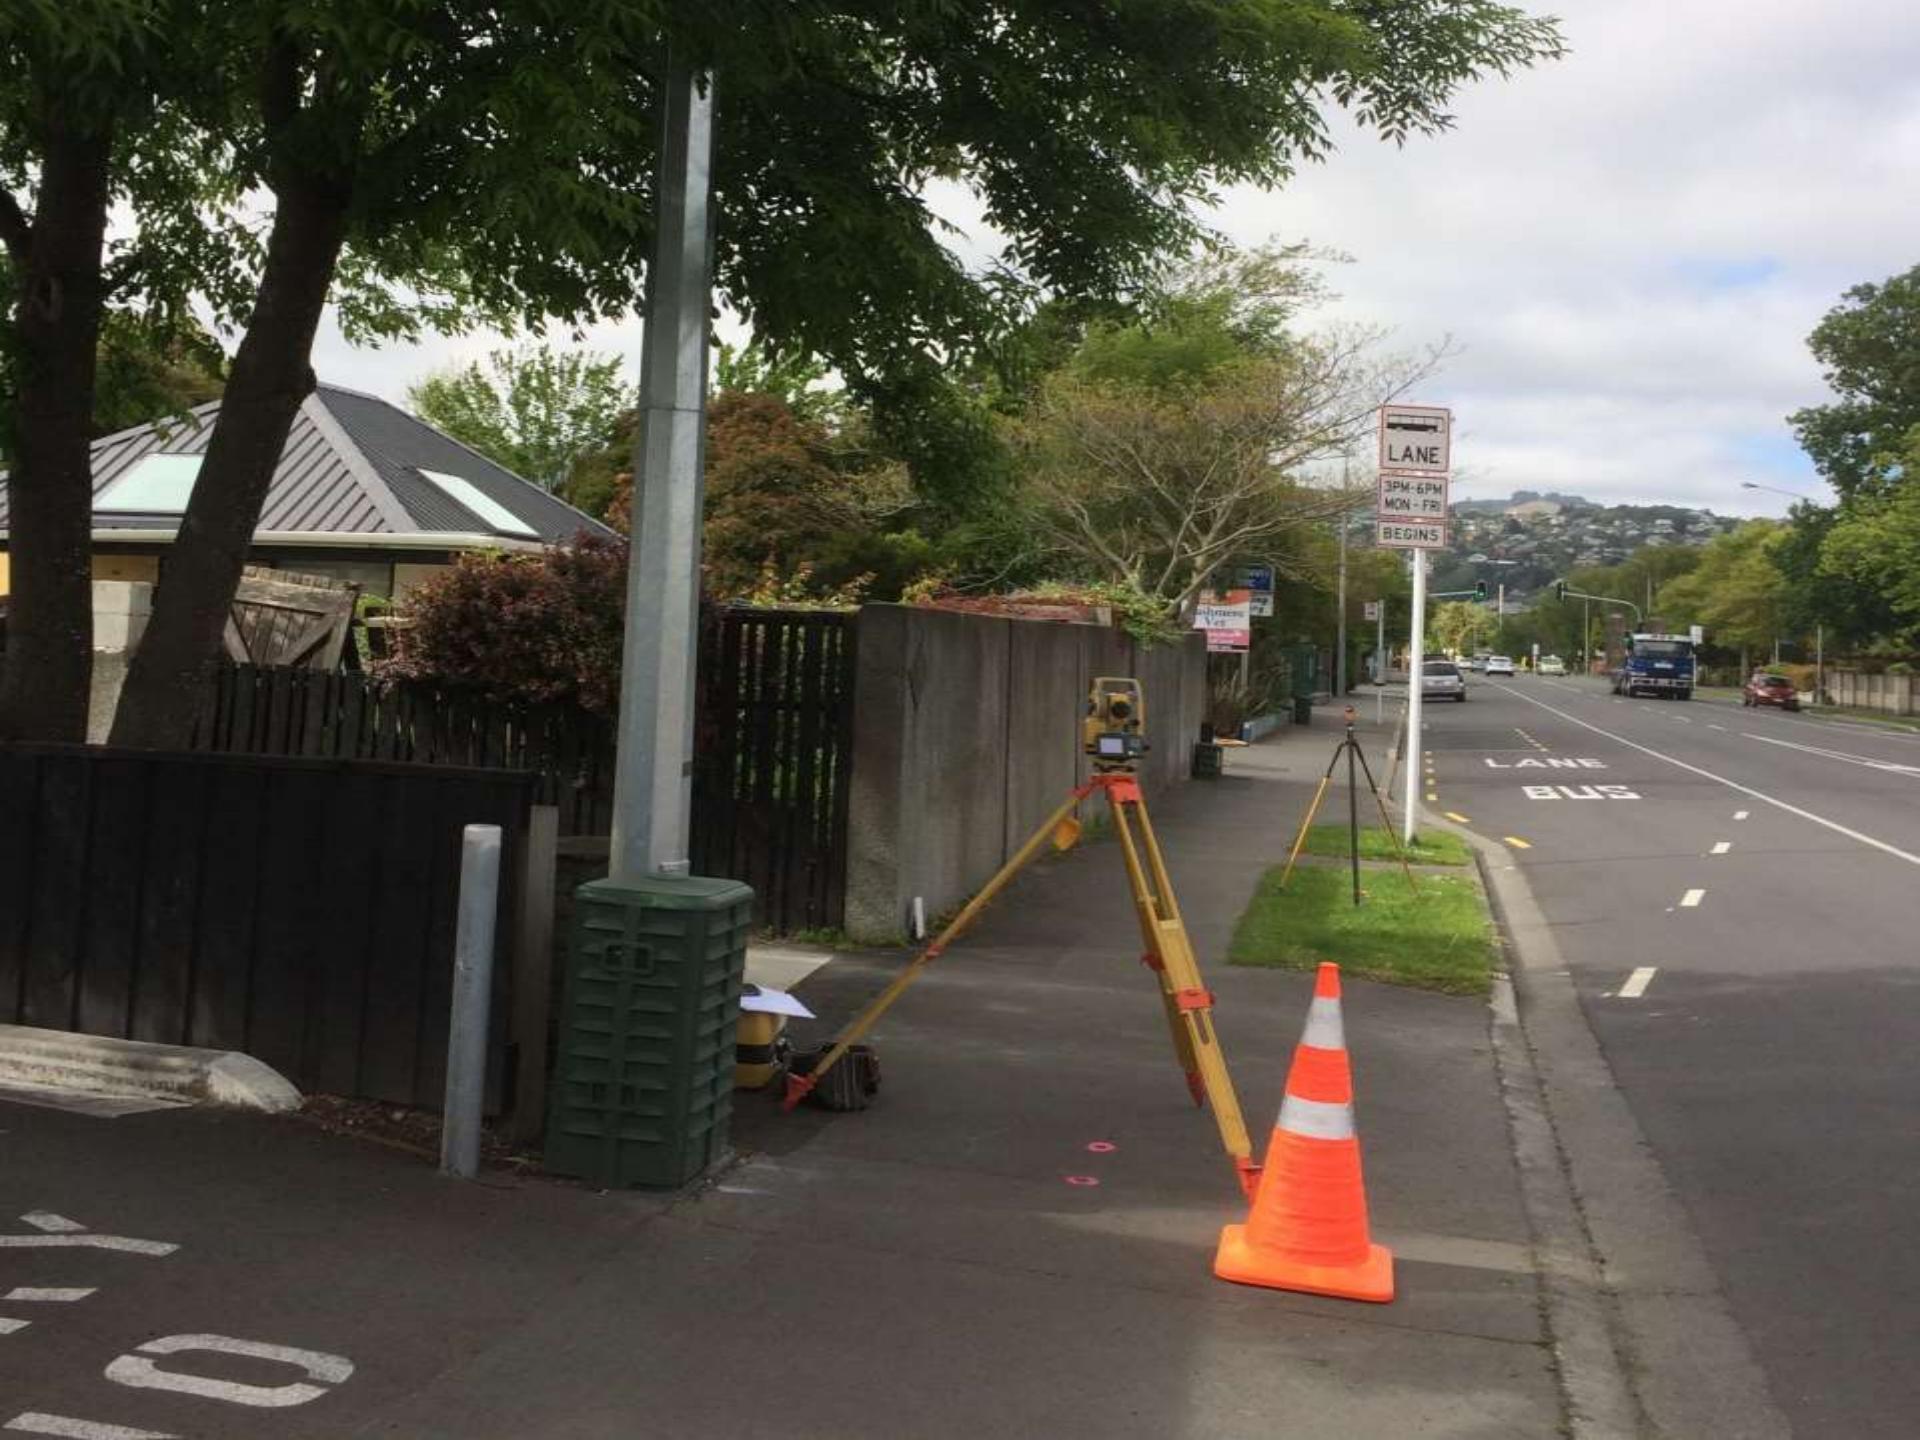
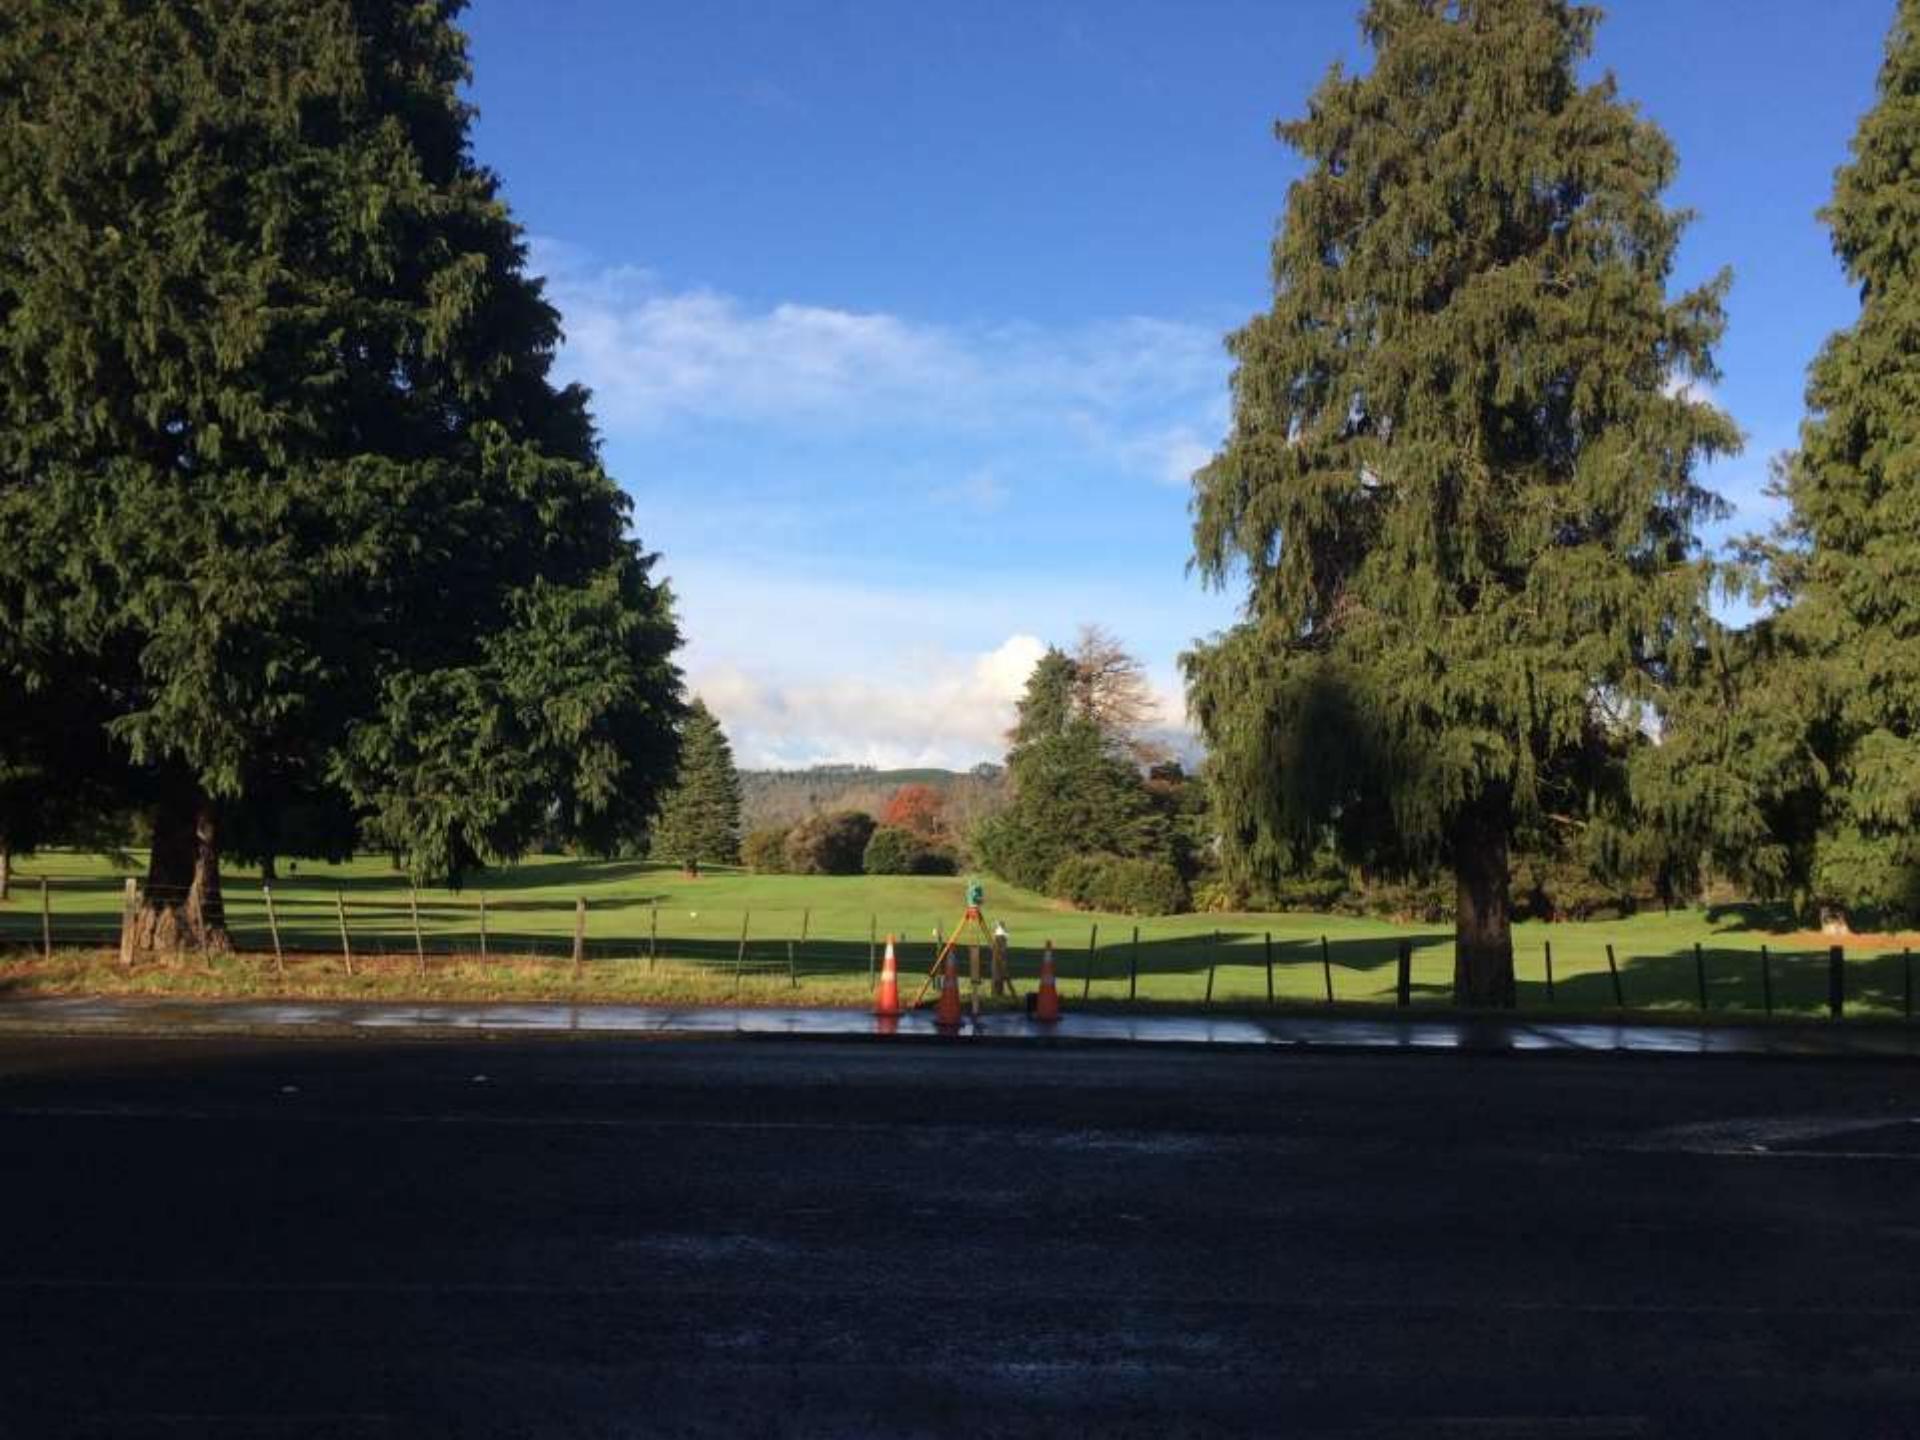
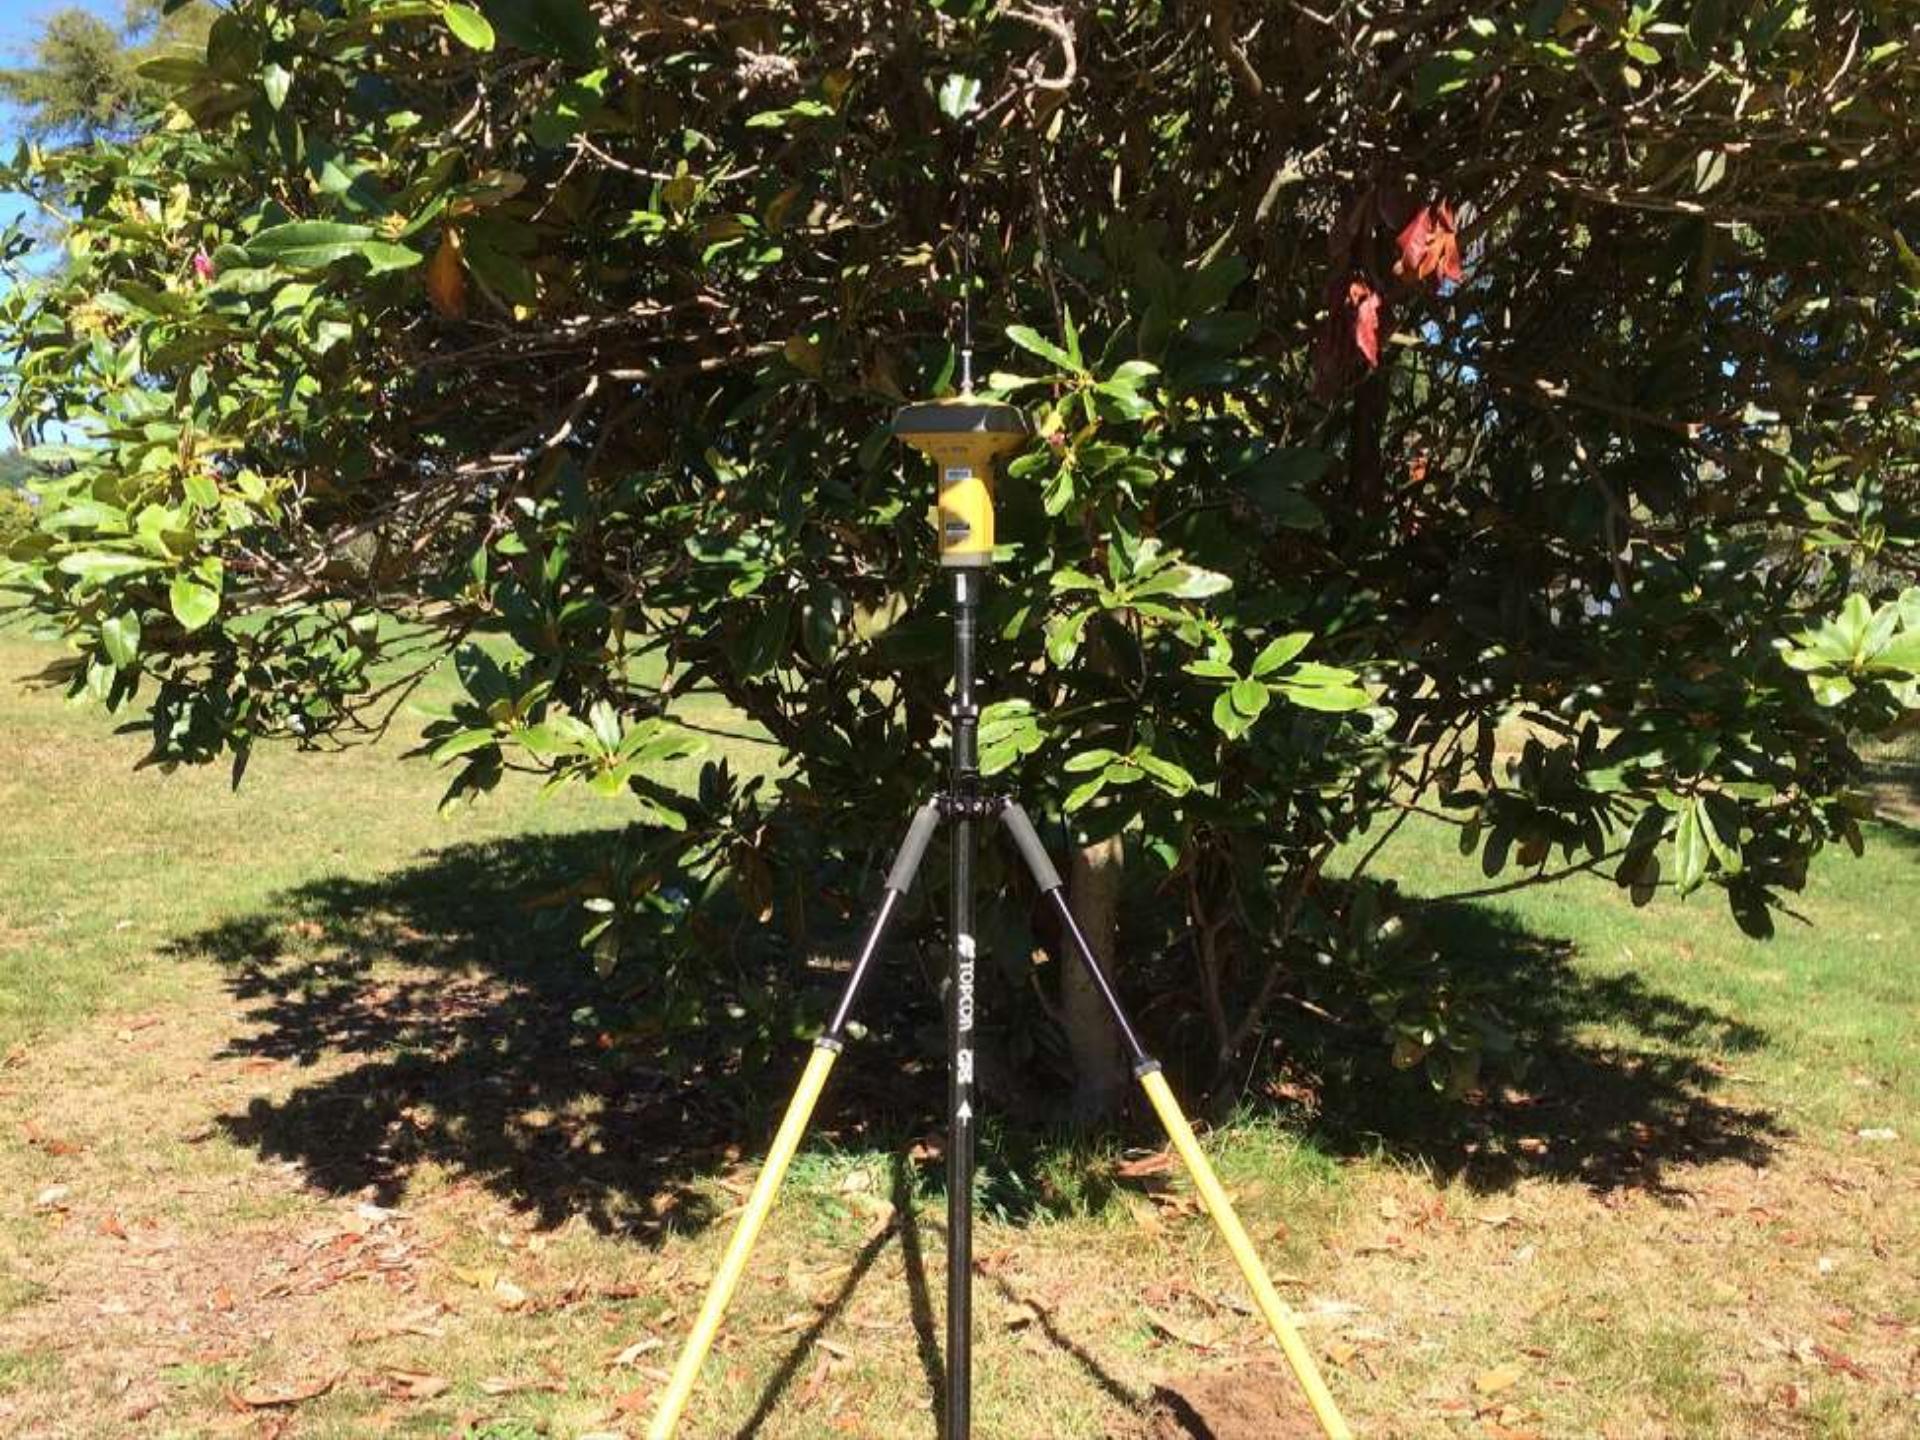
Poor GNSS horizons

- Inaccurate measurements due to poor GNSS horizons
- Weak or incorrect boundary definition
- Incorrect status of old marks (disturbed or reliable)
- Information in CSD not consistent with field record
- Inaccurate occupation information
- Adopted information does not match source
- Incorrect vector references
- Overwritten text
- Inaccurate and/or insufficient information in survey report
